## **TECHNICAL BULLETIN 06**

**DATE:** 30 June 2022

**SUBJECT:** Fathom-X PCBA populated with incorrect TVS diode

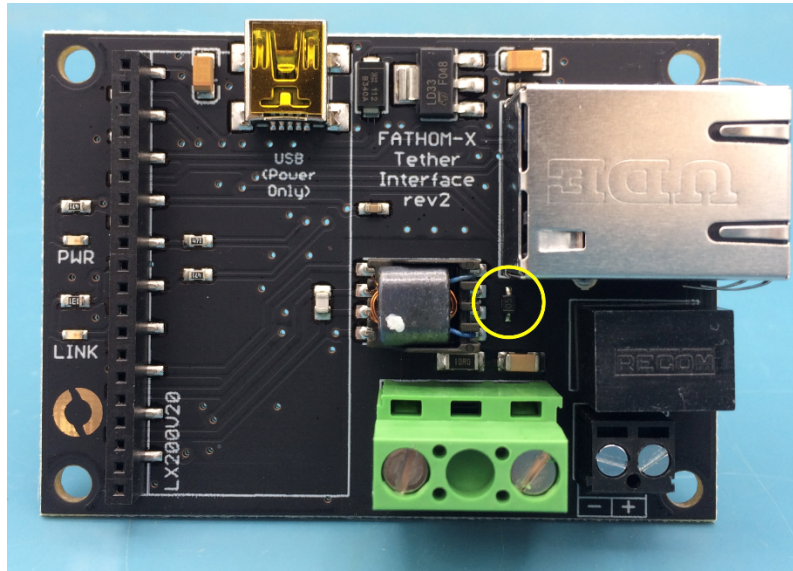
**IDENTIFICATION:** Blue Robotics recommends visually inspecting all Fathom-X Tether Interface Boards from orders shipped between May-June 2022 for incorrect diode component. Figure 1 shows the affected component TVS diode located between the connector corner and transformer. The correct diode is labeled “5C” and the incorrect diode is labeled “05” as shown in Figure 2.

Figure 1. Location of affected TVS diode

**CUSTOMER ACTION:** If you have any affected Fathom-X Tether boards or related products, please contact our support team at [support@bluerobotics.com](mailto:support@bluerobotics.com) with all available order information to receive replacement boards.

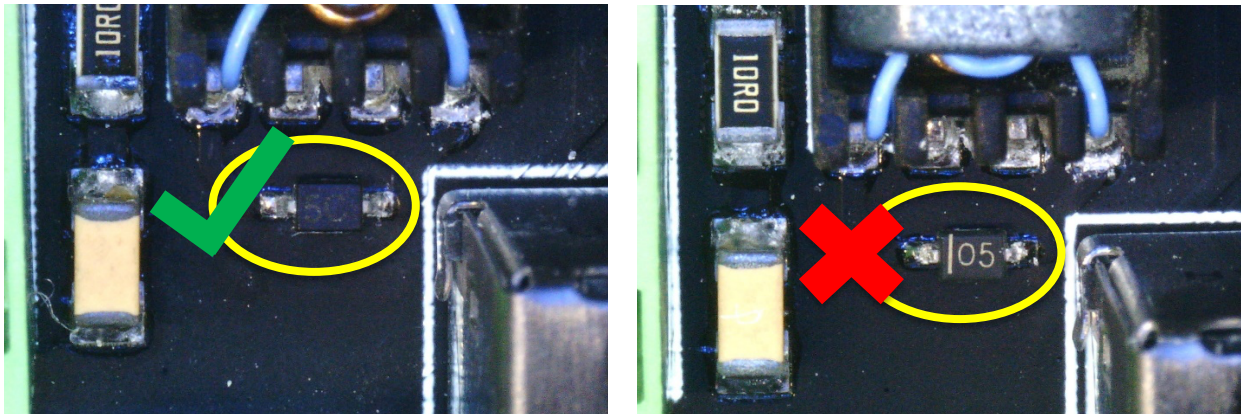
**SUMMARY:** At the end of June, connection issues were discovered and isolated down to the Fathom-X board. Due to a component sourcing mistake, some PCBAs were populated with an incorrect TVS diode. This severely reduces communication bandwidth and it affects the video streaming to unusable levels.

Figure 2. On the left is the correct component "5C" and on the right is the incorrect component.
