TECHNICAL BULLETIN 09

SUBJECT: BlueROV2 Camera Failure

SUMMARY: We have discovered that outdated Raspberry Pi4 firmware may be affecting the Low-Light HD USB Camera and causing camera failures. To ensure proper camera functionality, the Raspberry Pi's bootloader MUST be updated BEFORE a replacement camera is installed.

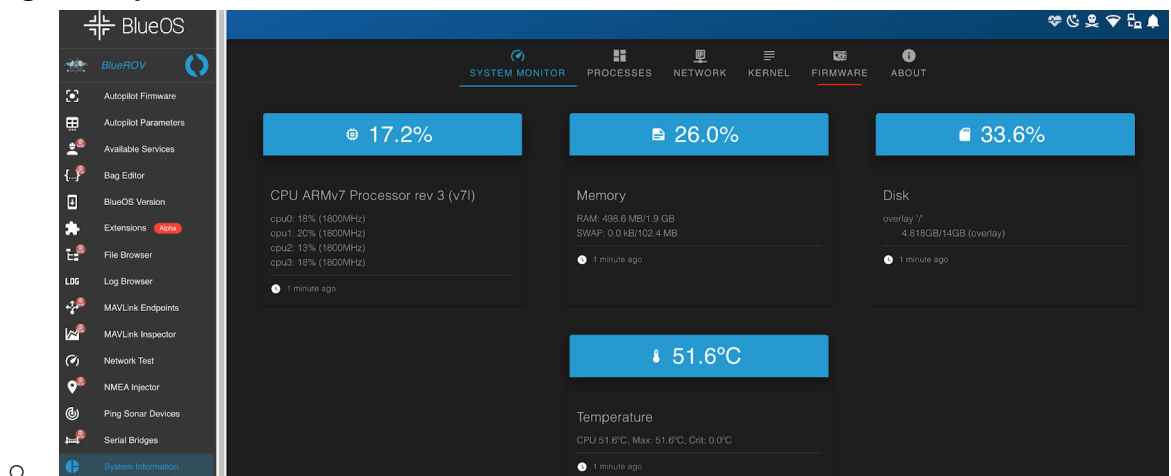
- Navigate to System information menu and select the Firmware

- If the bootloader is updated, it will show as "up to date," and no further action is required. However, if there is an update button, please proceed.
